THAMES VALLEY & GREAT WESTERN

NATIONAL OMNIBUS & TRANSPORT COMPANY 1927 LEYLAND PLSC3 LION

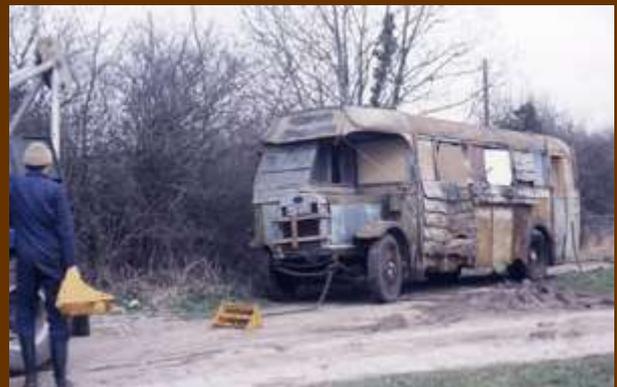
Spring 1987. Now pulled out onto the farm drive with original tyres inflated, all wheels turning, steering operational having been stationary for nearly 40 years. The pitched roof and boarding had provided protection to the original body although rain had penetrated and run down the body to rust away the skirts – nevertheless a remarkable survivor.

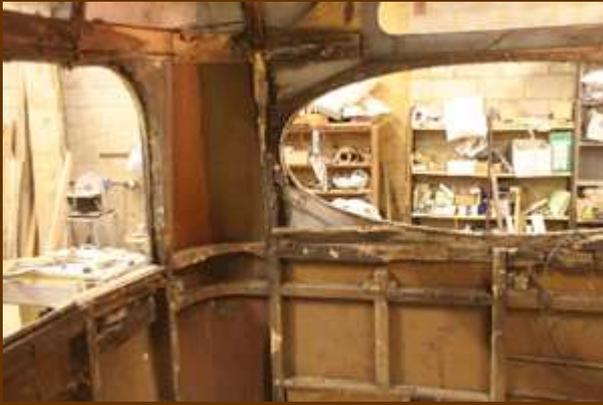
September 2008. A significant proportion of the timberwork in the rear needed replacing due to rot and woodworm

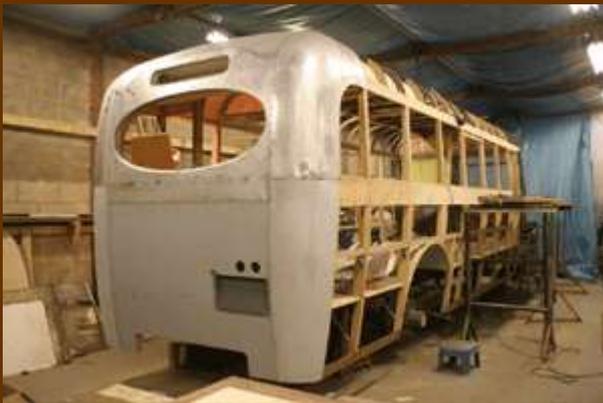
November 2009. The rear framing is now rebuilt and main panels attached. The upper panels (corner and centre rear domes) are original in aluminium whereas the lower panels which were originally steel were damaged and corroded so were replaced with new, again formed in steel.

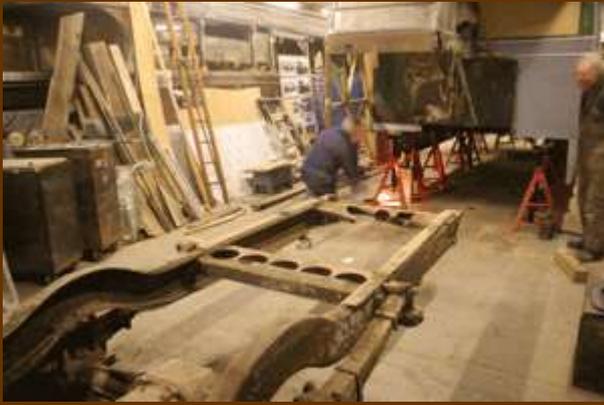
The chassis is remarkably complete with all parts in place. The major units (engine, gearbox, prop shaft, axles, fuel tank) were removed. At this stage it became obvious that the bus had been involved in a major accident which has resulted in damage to the main chassis frame, in particular the longitudinal main chassis rails. At the front both members were bent downwards from the saloon bulkhead to the dumb irons, the offside by 1.375" and the nearside by 0.375" which explained why the radiator had been leaning towards the offside. At the rear, the longitudinal members were bent sideways by about 1/2" from the front spring hangers on the rear axle to the back of the chassis and the rear cross member was heavily bent and mangled. It appears likely that the vehicle left the road and a frontal impact bent the front of the chassis downwards and then the vehicle was recovered by cutting a hole in the back of the body, wrapping a hawser or chain around the chassis rear cross member and pulling the vehicle back onto the road, bending the rear of the chassis sideways in the process. This is conjecture and we shall probably never know the details of what happened but it is thought that this would have been at some stage during the war when circumstances dictated a 'make do and mend' approach. The rear of the body had been repaired but the chassis damage remained.

Damage to the rear cross member previously hidden behind the body lower rear panelling – we have an explanation. (Nov 2011)

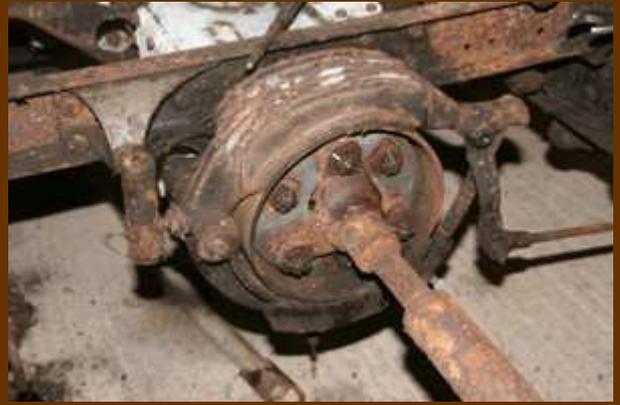
Flexible rubberised fabric prop-shaft coupling inside the transmission brake drum. New couplings are now (February 2013) being produced to the original design by a company in Birmingham.

Since painting we have been re-assembling the chassis which is now back on its axles with gear box in place. We are currently waiting for replacement prop-shaft flexible joints which we are having made to the original pattern and prop-shaft centre bearing seal plates which are being re-cast. Once these components are installed the chassis will be put back under the body which will enable construction of the cab.

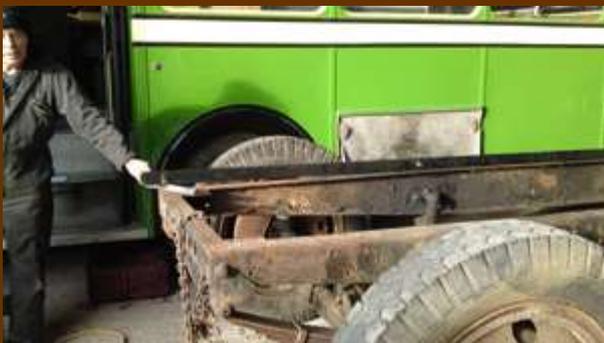
The offside rail was bent downwards from the front saloon bulkhead to the dumb iron as demonstrated by the gap below the black painted straight edge to the top of the chassis rail. (Jan 2012)

Our intention is to restore the vehicle to 1935 as-rebodied, roadworthy condition so it was necessary to repair the damage before continuing. This was done by a company called Chassis Alignment at Wisbech in Cambridgeshire to whom we took the complete chassis in January 2012. They have a strong floor with a grid of heavy steel members cast into it so they can apply upwards, downwards and sideways loads to different parts of the chassis. The skill is being able to know how much to push and pull to overcome the elastic (recoverable) deformations and bring about the correct amount of plastic deformation to permanently set the steel members to where they should be. Chassis Alignment did the job quickly and accurately, and are thoroughly recommended.

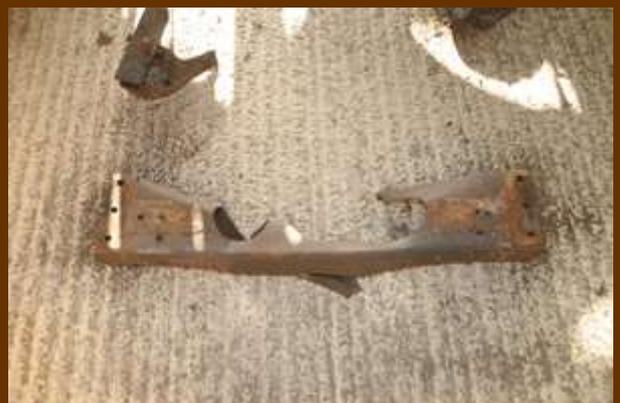
The damaged rear cross member. (Jan2012)

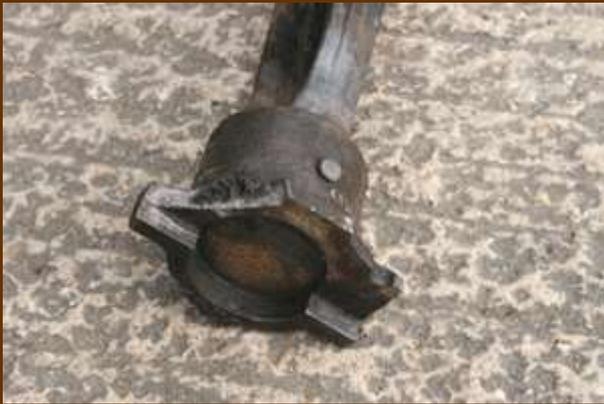
Fractured casting on the rear engine support cross member. (Feb 2012)

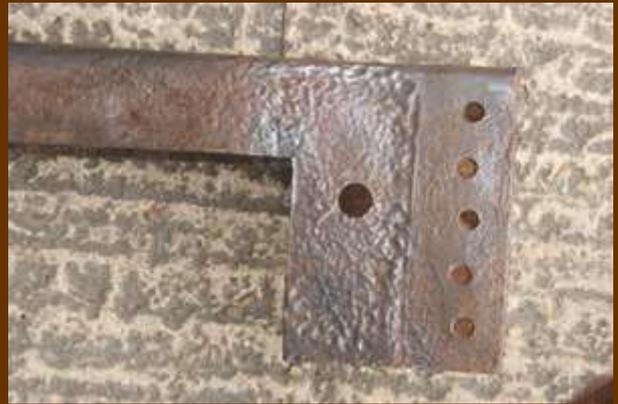
Cracking in the front cross member. (Feb 2012)

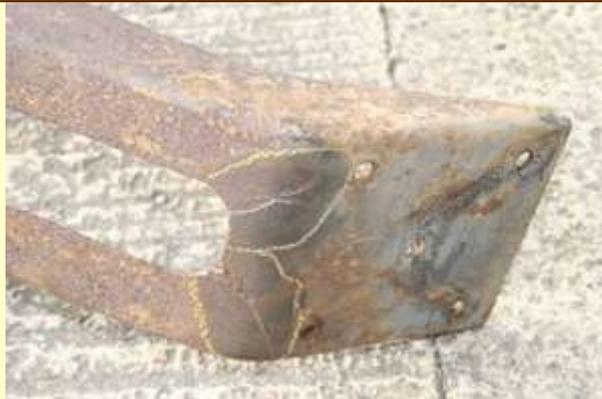
Cracking in the centre bearing cruciform cross member. (Feb 2012)
