THAMES VALLEY & GREAT WESTERN

NATIONAL OMNIBUS & TRANSPORT COMPANY 1927 LEYLAND PLSC3 LION

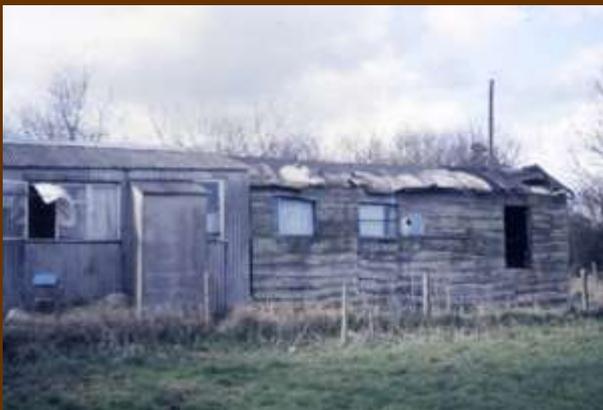
On the farm near Crewkerne – the appearance completely hides the existence of the bus under the rustic boarding. By this time the cab door had parted company but the original half drop window was still in place.

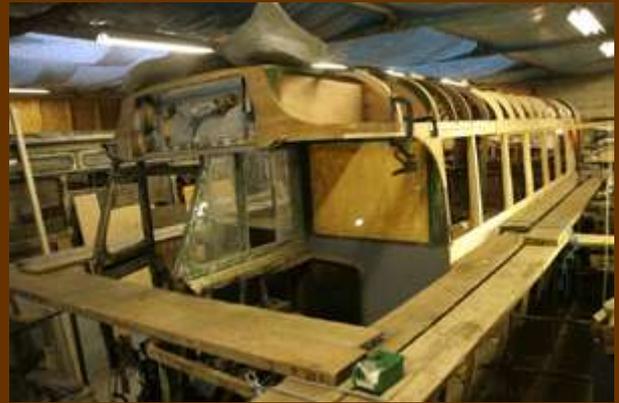
September 2008. Nearside framing well underway with pieces scarfed into the roof sticks where they meet the cant rail and new pillars in place.

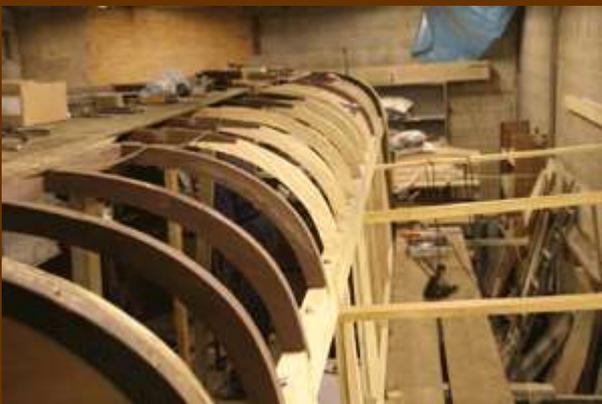
September 2008. The cant rail is in two parts as Mumfords jig built the sides and roof as separate pieces and bolted the roof to the top of the sides. The pillars at the front of the rearmost side windows and the joining roof stick were also split along their lengths as the rear was also built as a separate structure and bolted onto the main part of the body structure.

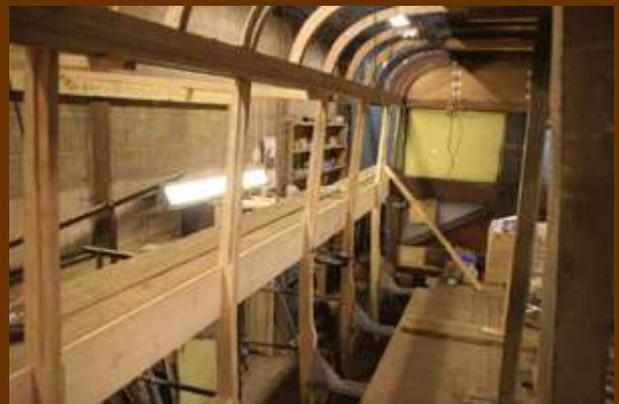
September 2008. Fitch plates connect the pillars to the original steel channel section floor bearers

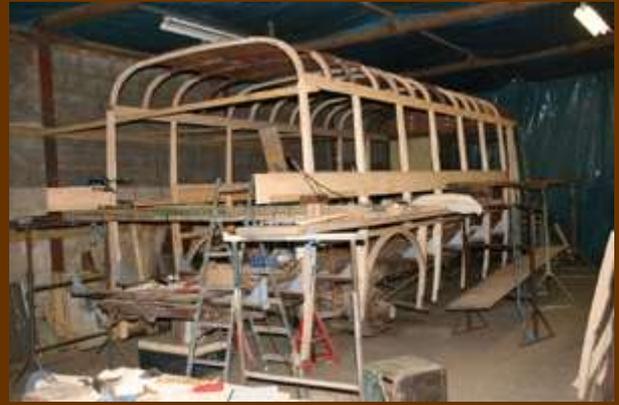
February 2009. With the original rear end removed the offside waist rail could be installed. We built the rear onto the side frames

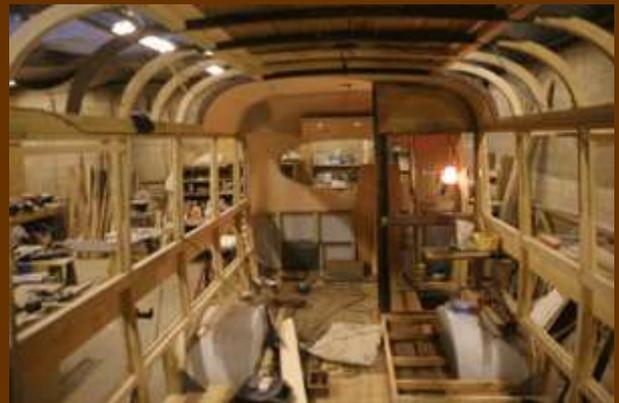
November 2009. Inside after reconstruction of the rear end. The original blind box has been re-installed together with internal lining panels to the domes. Markings on the floor show where the seat supports, plinths around the wheel arches and wearing slats for passengers feet were originally located so these features can be correctly reproduced.

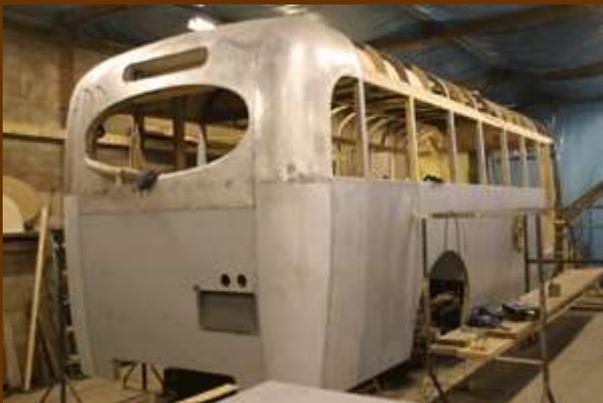
January 2010. Main lower side panels are cut from zintec (zinc coated sheet steel) to provide stiffness and strength in the lower body. Some of the window cappings are installed

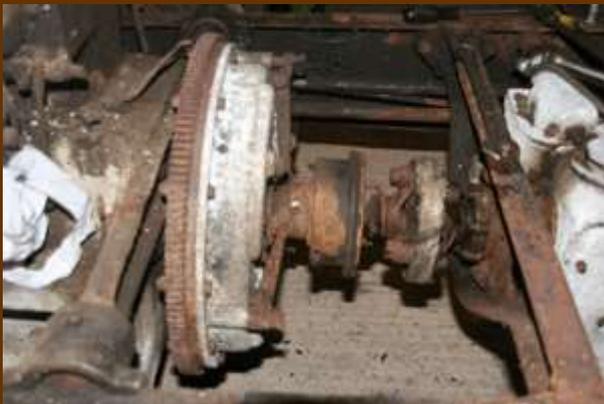
Another flexible 'rag' coupling between the clutch (left) and the gear box. (Nov 2011)

Since painting we have been re-assembling the chassis which is now back on its axles with gear box in place. We are currently waiting for replacement prop-shaft flexible joints which we are having made to the original pattern and prop-shaft centre bearing seal plates which are being re-cast. Once these components are installed the chassis will be put back under the body which will enable construction of the cab.

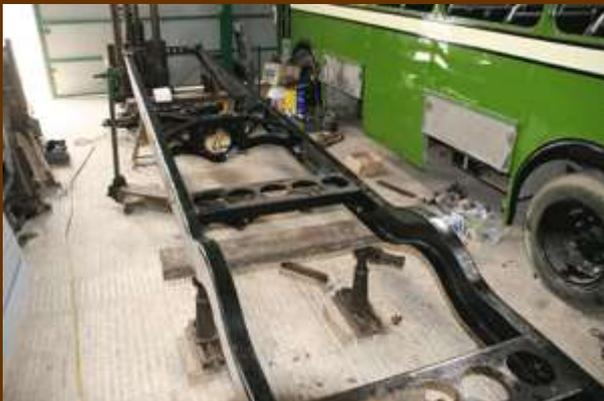
The straightened, repaired and painted chassis starts to take shape. (May 2012)

Our intention is to restore the vehicle to 1935 as-rebodied, roadworthy condition so it was necessary to repair the damage before continuing. This was done by a company called Chassis Alignment at Wisbech in Cambridgeshire to whom we took the complete chassis in January 2012. They have a strong floor with a grid of heavy steel members cast into it so they can apply upwards, downwards and sideways loads to different parts of the chassis. The skill is being able to know how much to push and pull to overcome the elastic (recoverable) deformations and bring about the correct amount of plastic deformation to permanently set the steel members to where they should be. Chassis Alignment did the job quickly and accurately, and are thoroughly recommended.
